# CAPITAL IMPROVEMENT PLAN

**EAST PALO ALTO  
SANITARY DISTRICT**

**December 2023**

**SIERRA WEST  
CONSULTANTS, INC.**

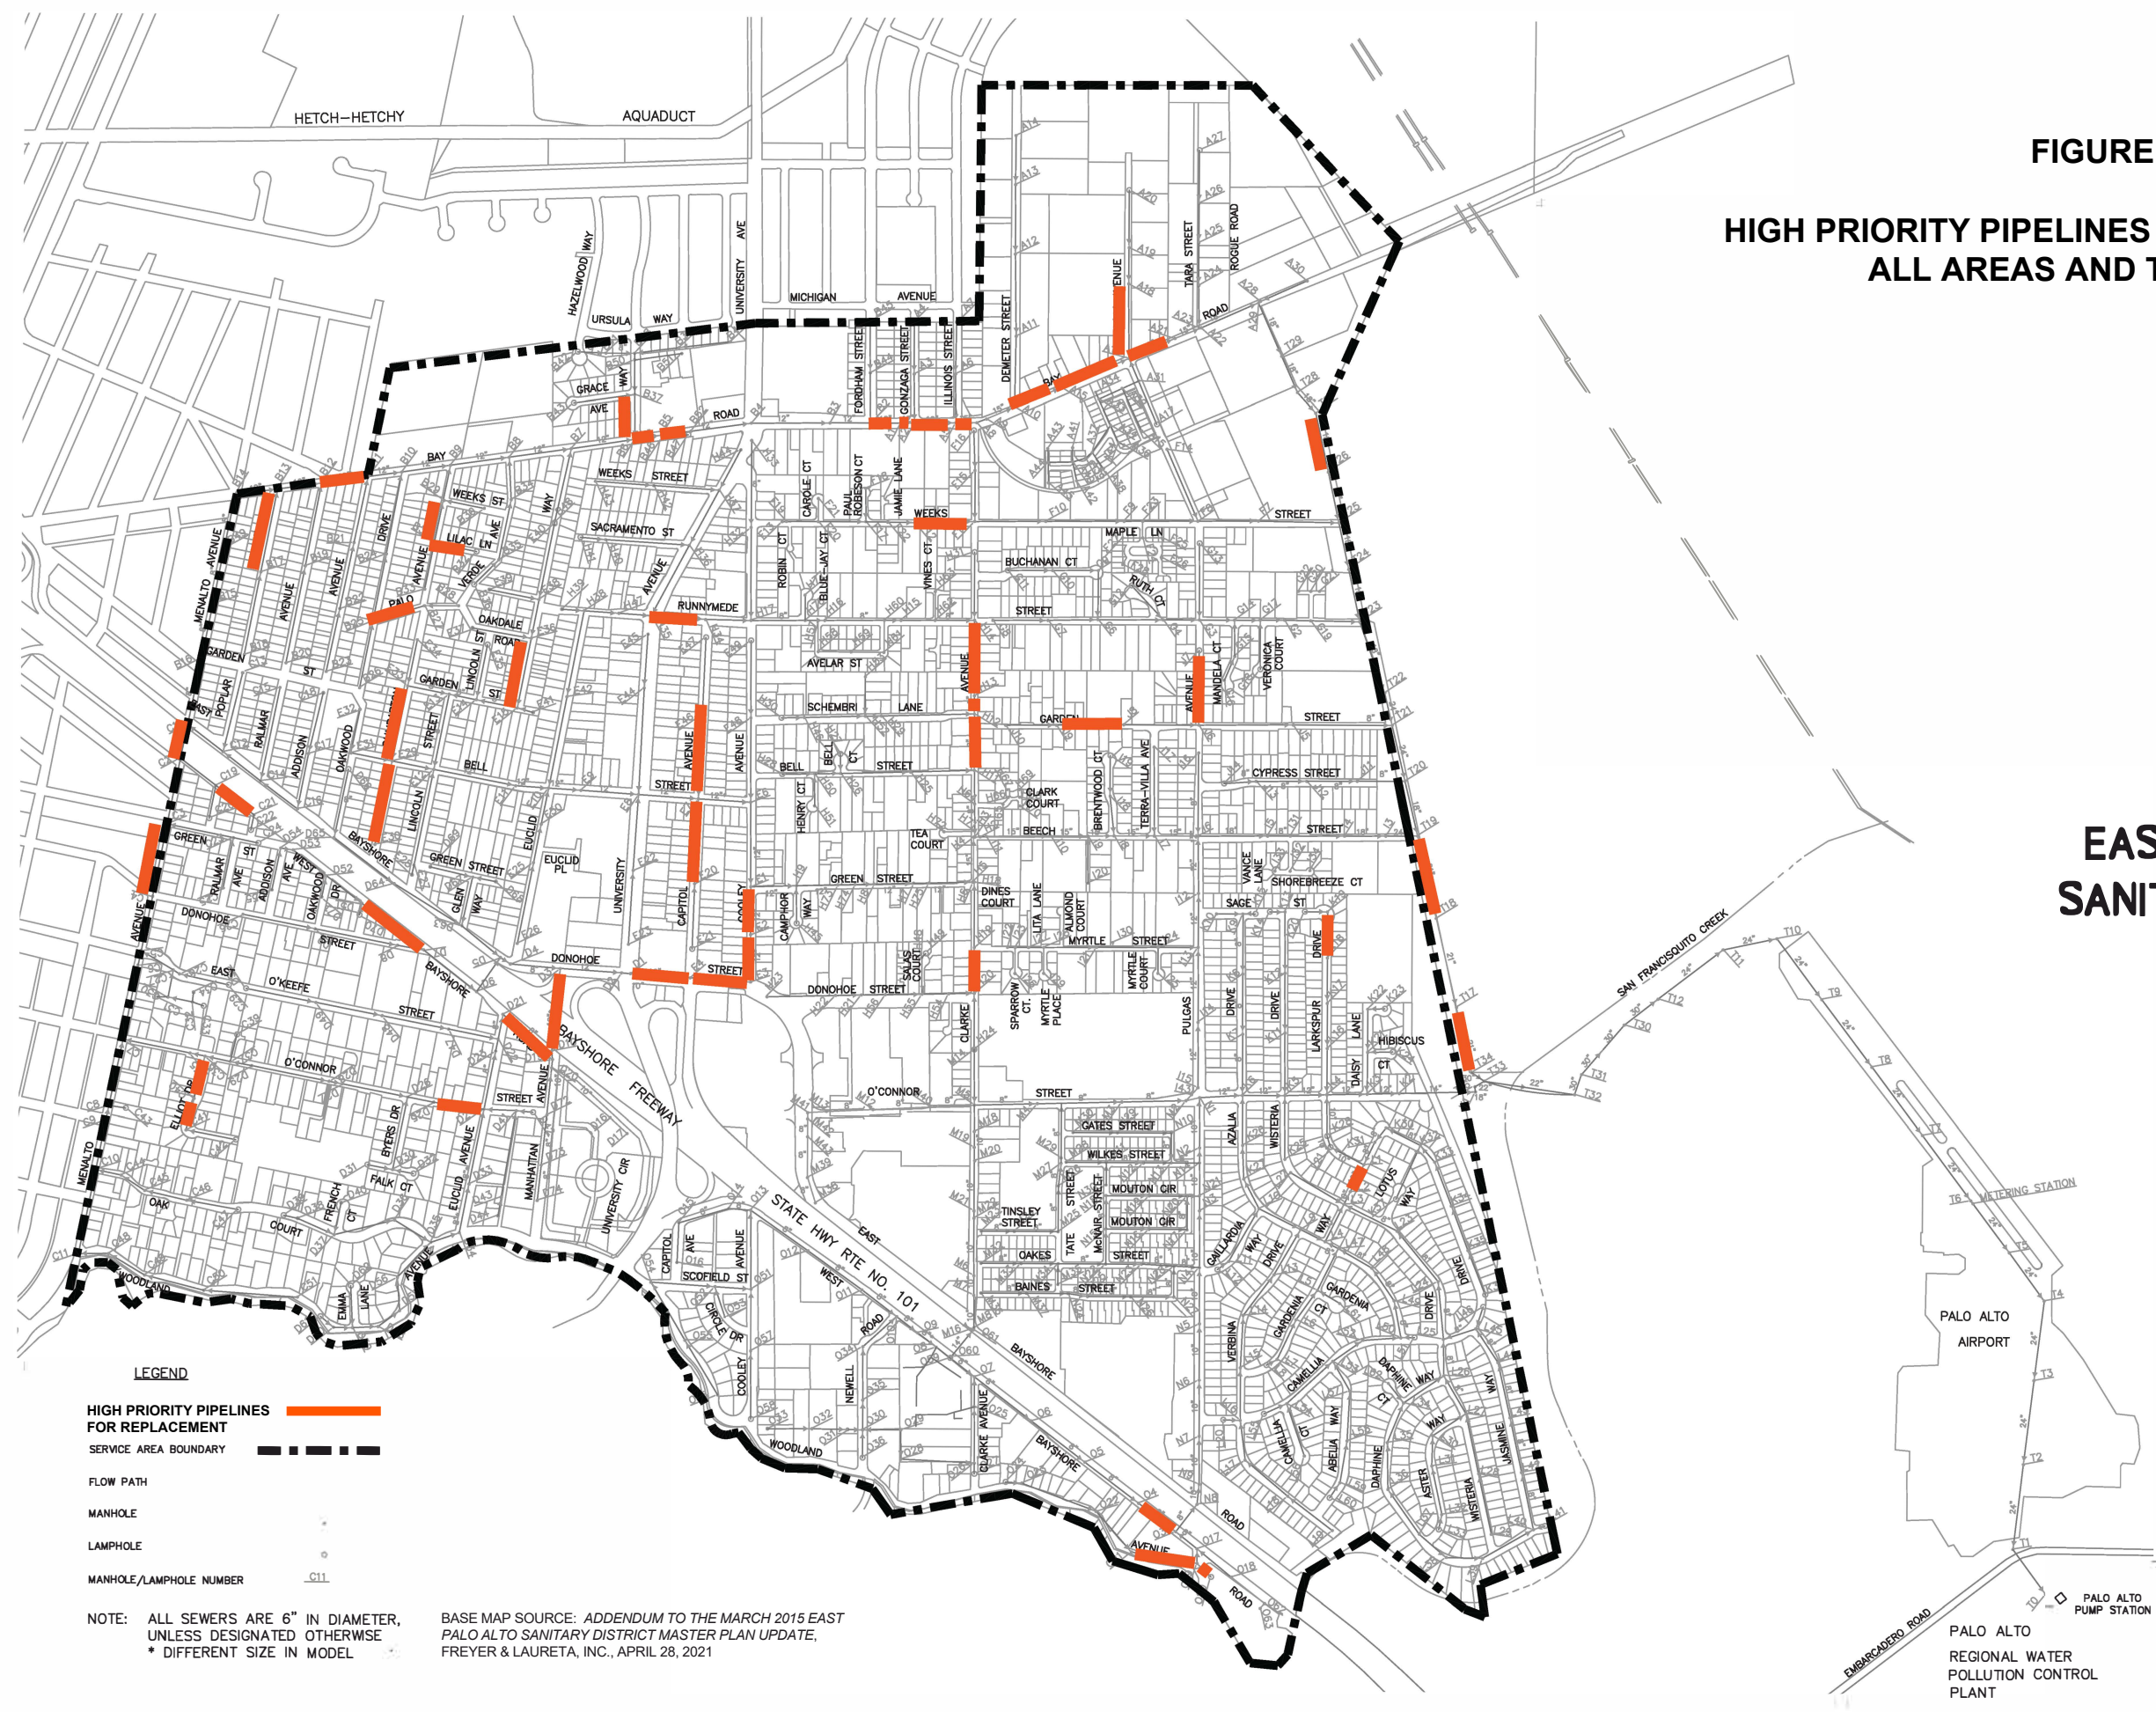
FIGURE 2

The highest priority pipelines for replacement, with scores greater than 105, are shown in Figure 2. The opinion of project cost for these pipelines is \$12.5M and includes two crossings of the Bayshore Freeway and three trunk line replacements. To manage the projects efficiently, approximately \$6M of pipeline replacements are highlighted in Figure 3 as the first phase. While this phase is under construction, a second phase can be designed and permitted with CalTrans to address the freeway crossings. It is also recommended to delay the upper trunk line segments because these are in good structural condition.

HIGH PRIORITY PIPELINES FOR REPLACEMENT  
ALL AREAS AND TRUNK LINE
